Analysis of Brownfield Cleanup Alternatives

Former K-Mart, 5597 Buford Highway
Doraville, DeKalb County, Georgia

Analysis of Brownfields Cleanup Alternatives

Phase II Environmental Site Assessment

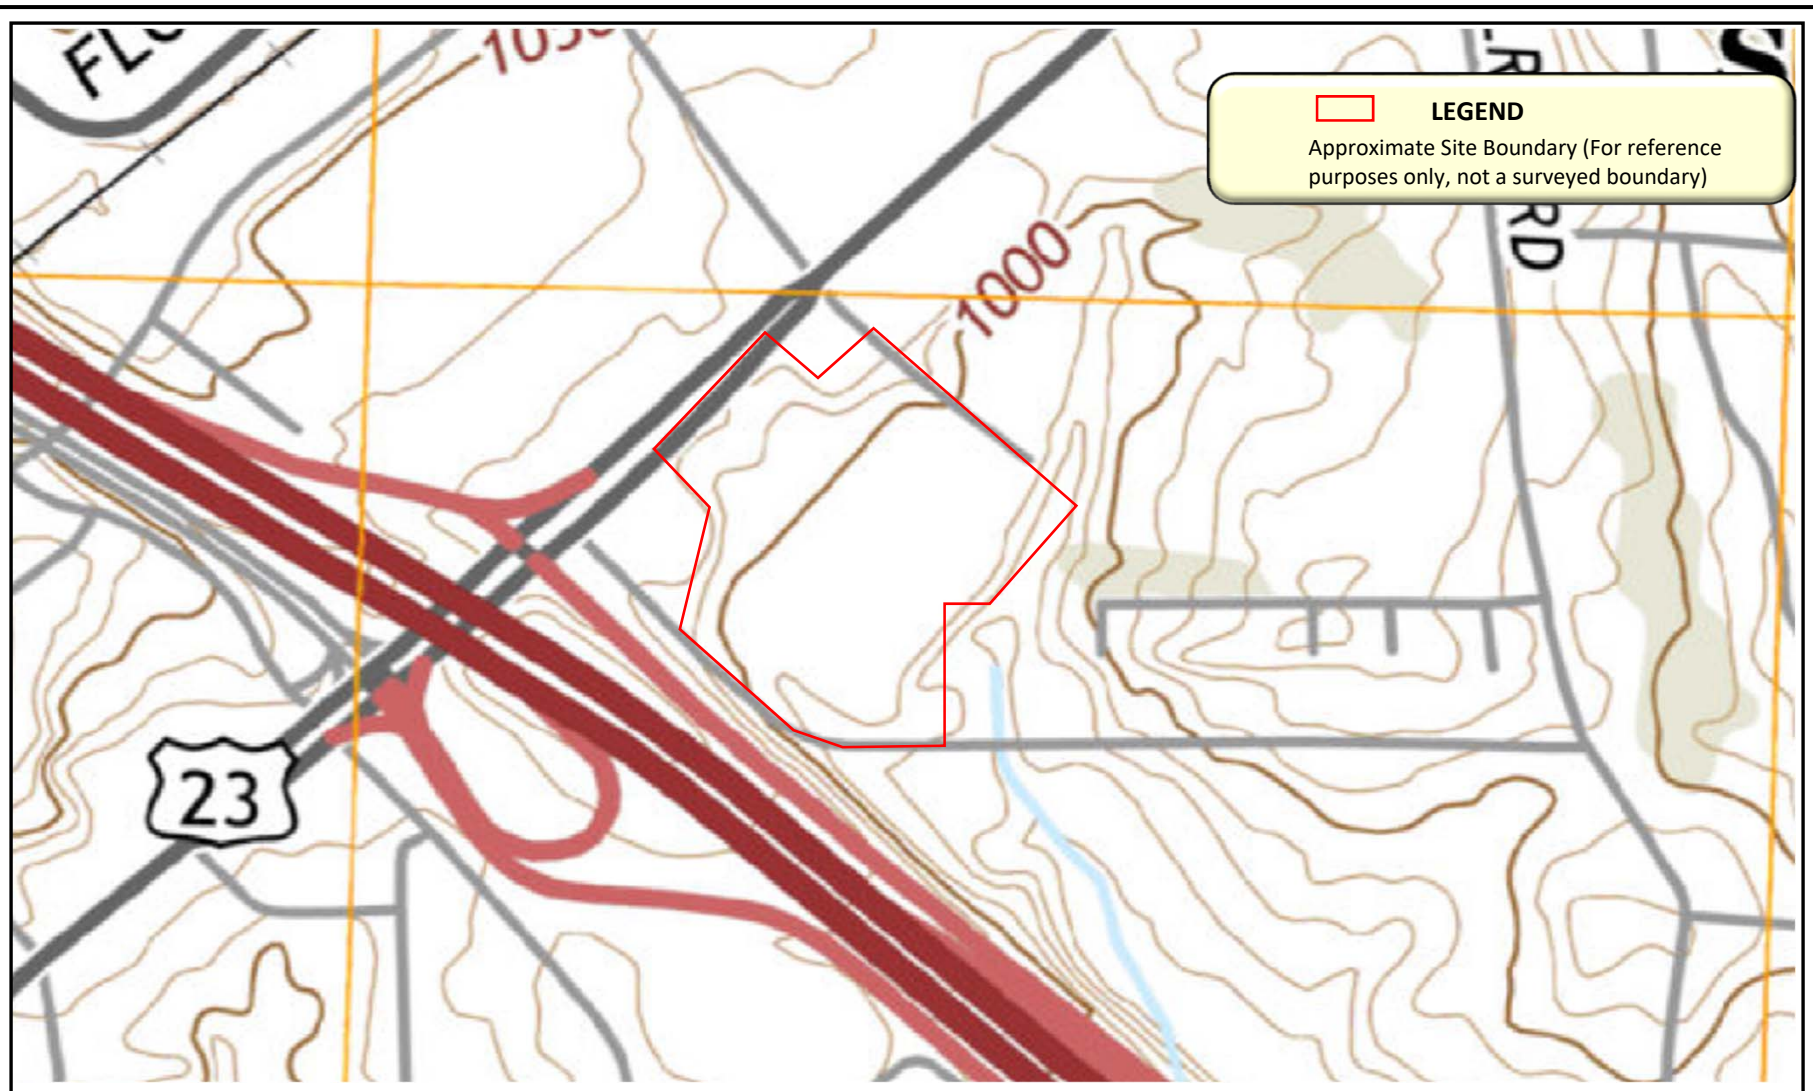
Figure 1
USGS/Site Vicinity Map
Source: USGS 2014

Approximate Site Boundary (For reference purposes only, not a surveyed boundary)

Cardno has completed a Phase II Environmental Site Assessment of the property identified as the former K-Mart located at 5597 Buford Highway, Doraville, DeKalb County, Georgia. The study property is herein referred to as "the subject site/property" or "the site" (as generally depicted in **Figures 1 and 2**) and consists of approximately 13 acres of land currently listed as owned by Southern Gas Partners, LLC.

Cardno was retained by the Client to conduct this Phase II ESA of the property located at 5597 Buford Highway, Doraville, Georgia (**Figures 1 and 2**). This investigation was conducted in general conformance with the scope and limitations outlined by *ASTM Standard E 1903-11*; however, the specific scope of work was negotiated between the Client and Cardno to meet the objectives of the Client. The primary objectives were to evaluate the identified RECs (as defined in *ASTM Standard E1527-05*) and asbestos and lead-based paint to provide sufficient information regarding the nature and extent of contamination (if present) to assist in making informed business decisions about the property; and where applicable, providing the level of knowledge necessary to satisfy the Landowner Liability Protection provisions under CERCLA. RECs are defined by *ASTM Standard E1527-05* as: “the presence or likely presence of any hazardous substances or petroleum products on property under conditions that indicate an existing release, a past release, or a material threat of a release of any hazardous substance or petroleum products into structures on the property or into the ground, groundwater, or surface water of the property.”

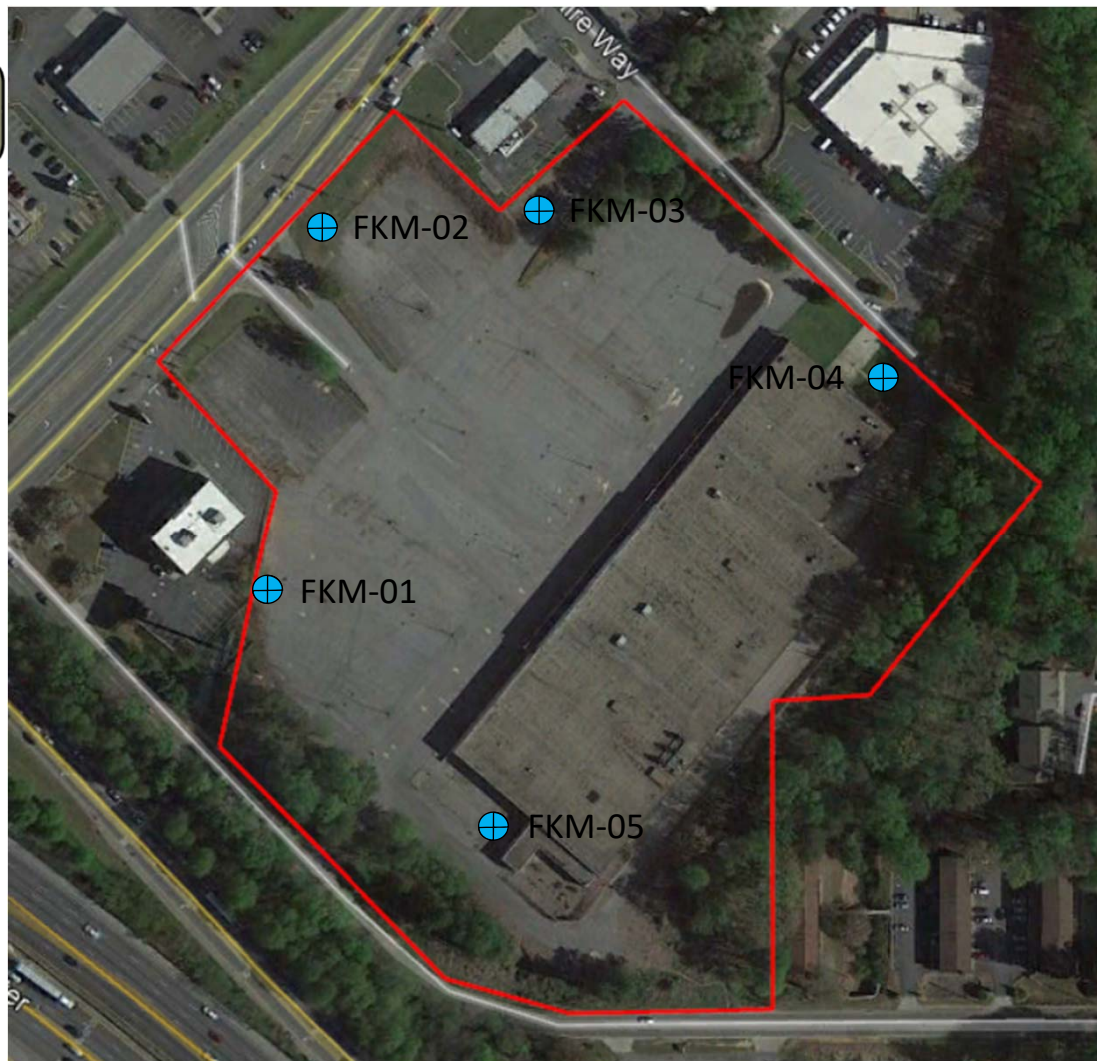
Monitoring Well Location

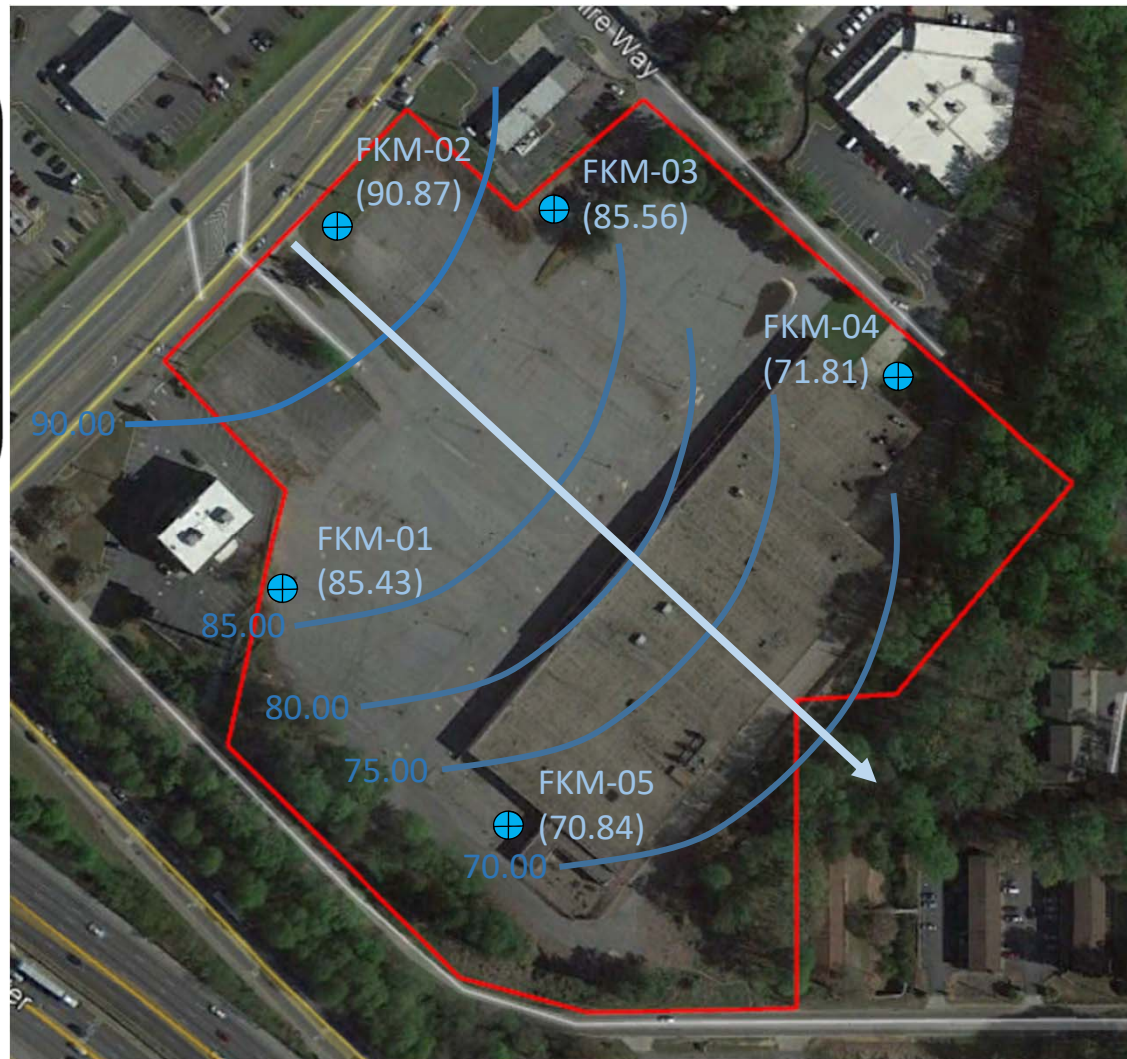
Figure 5
Groundwater Flow Direction Map

- Monitoring Well Location
- Groundwater Flow Direction
- Potentiometric Surface Contour
- FKM-01 Potentiometric Surface (85.43) Elevation
- Subject Property
